City of Louisville

Marshall Fire Water System Recovery Summary Report

Corona Environmental Consulting, LLC

2/3/2025

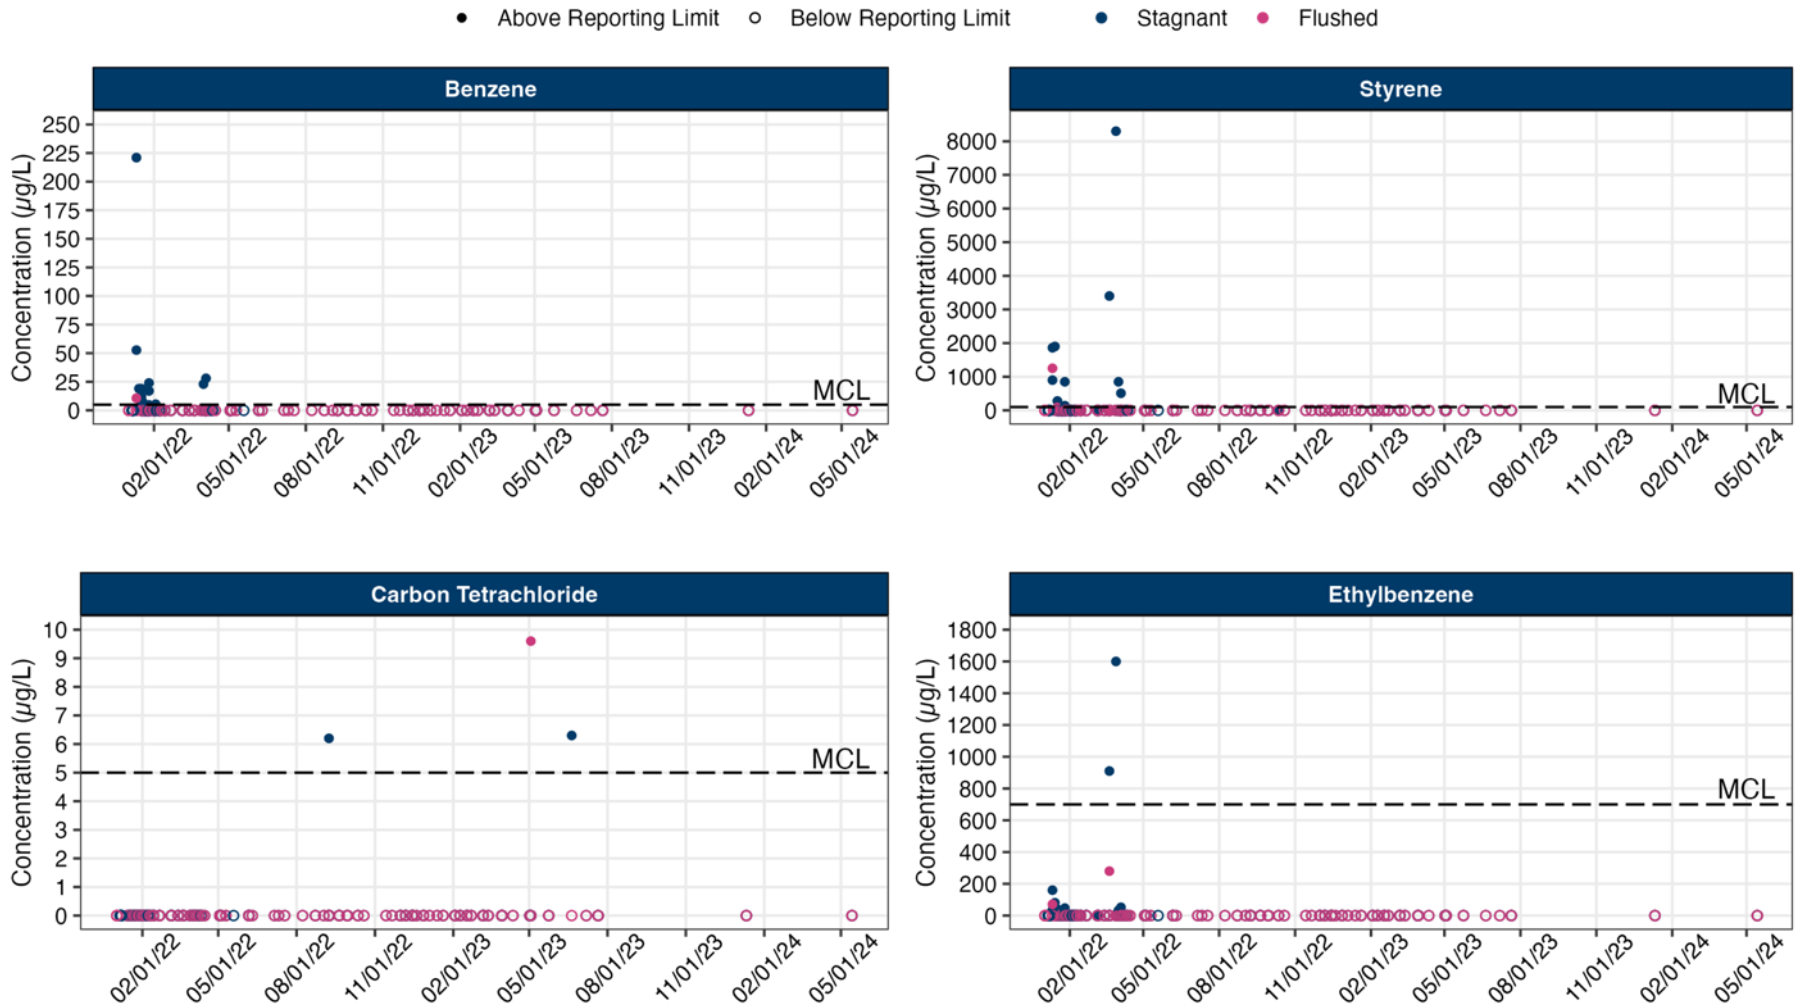
¹ Follow up sampling and typical carbon tetrachloride sources indicate possible construction or sampling cross contamination for meter pit results, not necessarily fire-related contamination

Figure 9. Concentrations over time of the contaminants that exceeded an MCL - includes results from all stages of water system recovery

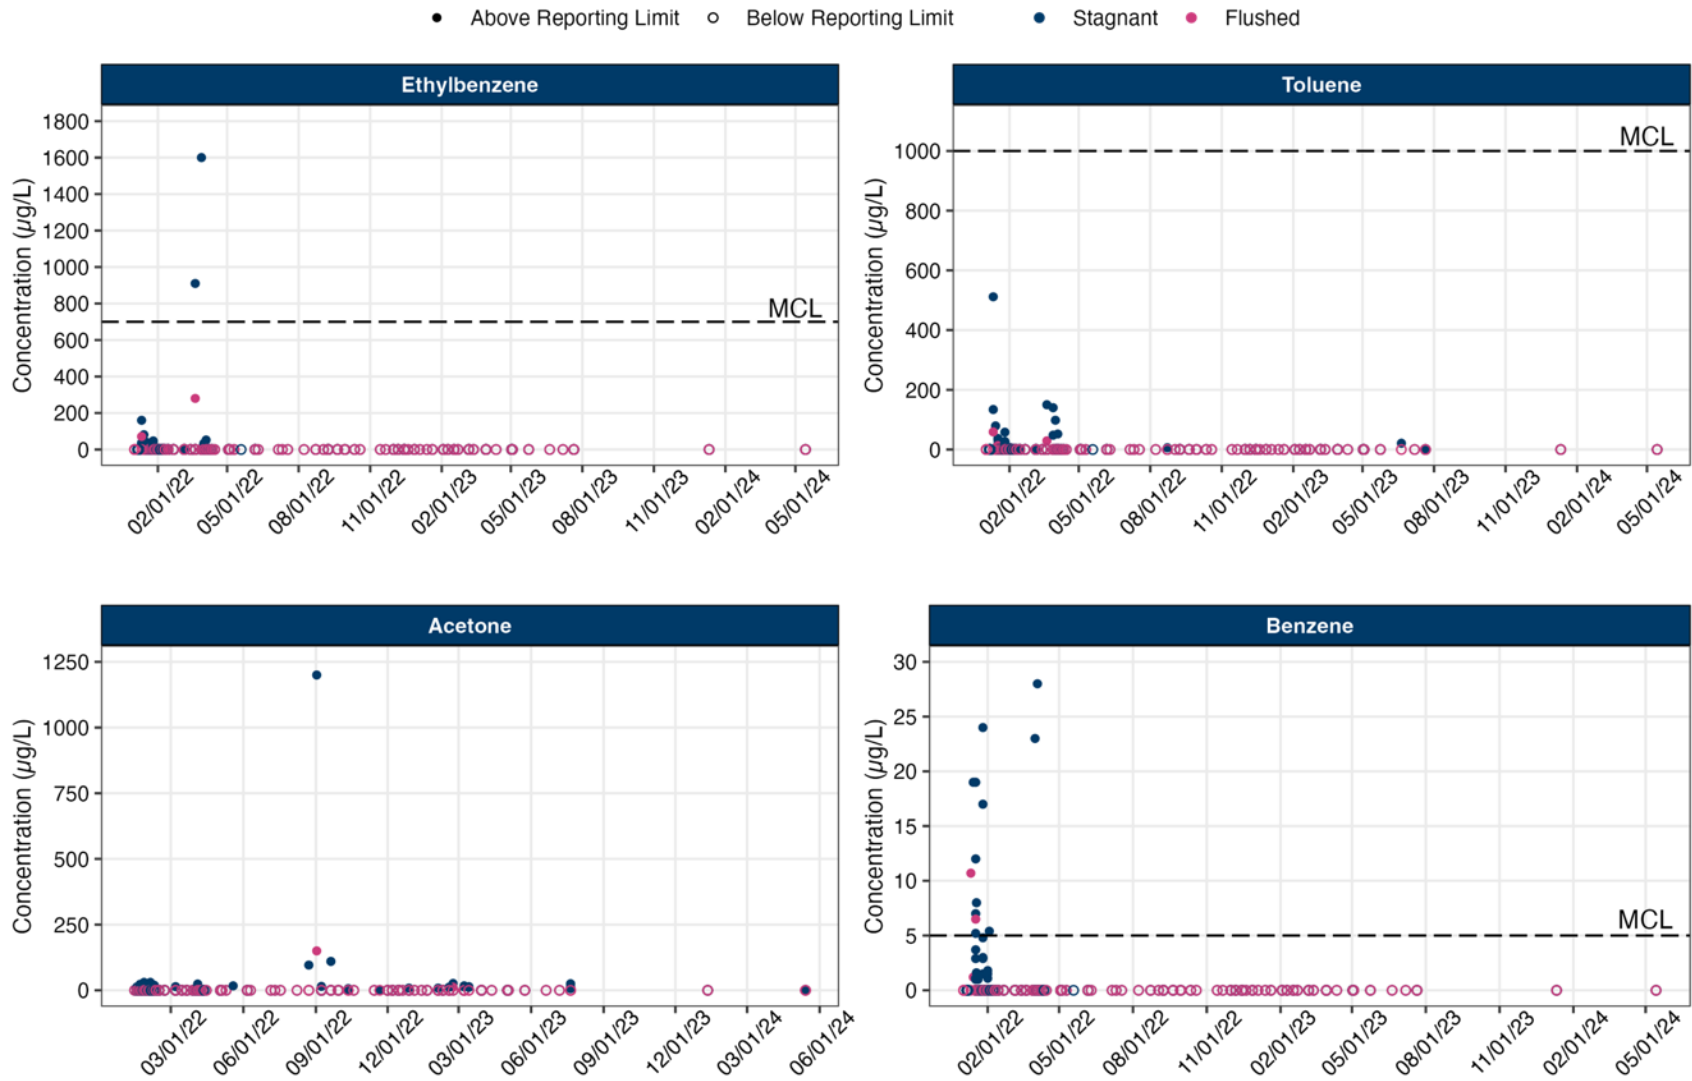
Figure 10 and Figure 11 show concentrations over time for the contaminants most frequently detected above the MRL. This includes sample results from all sample stages at all locations. An MCL is shown for regulated contaminants; unregulated contaminants do not have an MCL.

Figure 10. Sample concentrations over time for contaminants most frequently over the MRL – includes results from all stages of water system recover (1 of 2)

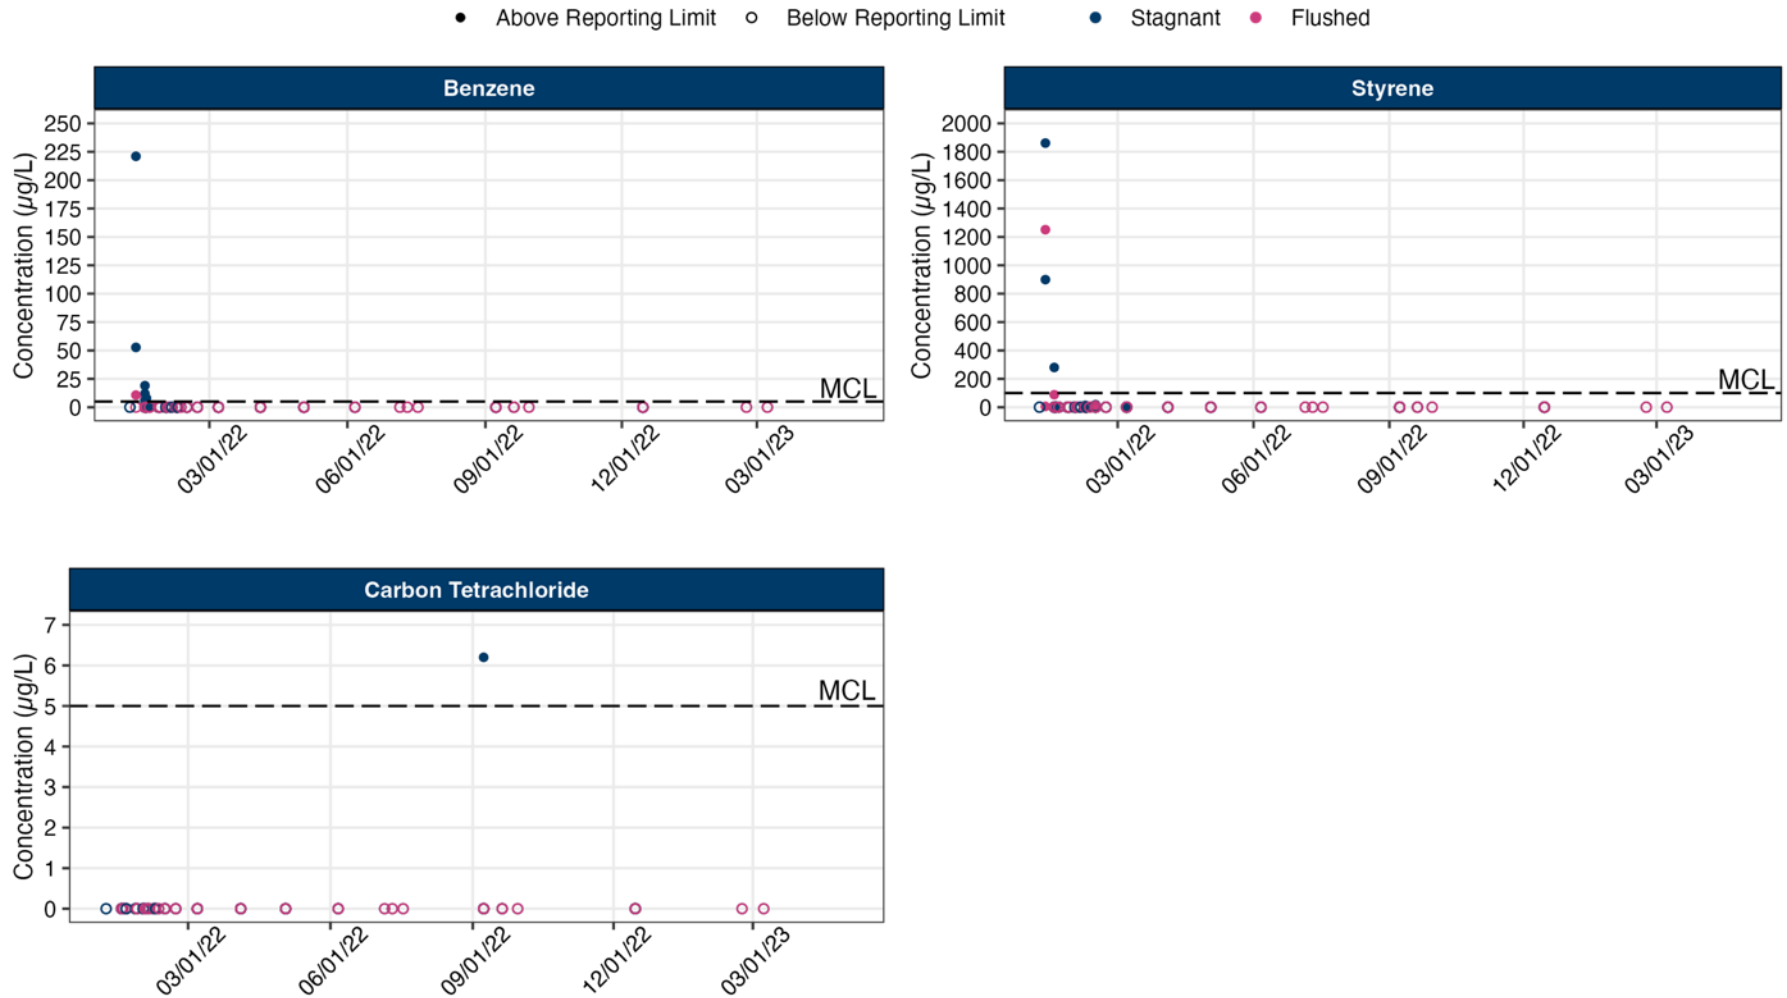
Sample Stage	Contaminant	Number of Detections >MCL	MCL (µg/L)	Maximum Concentration (µg/L)	Detected in Historic Post-Wildfire Drinking Water Sampling
Distribution System	Benzene	9	5	221	Y
	Styrene	4	100	1,862	Y
	Carbon Tetrachloride	1	5	6	Y

Figure 12. Contaminants detected above the MCL in distribution system sampling

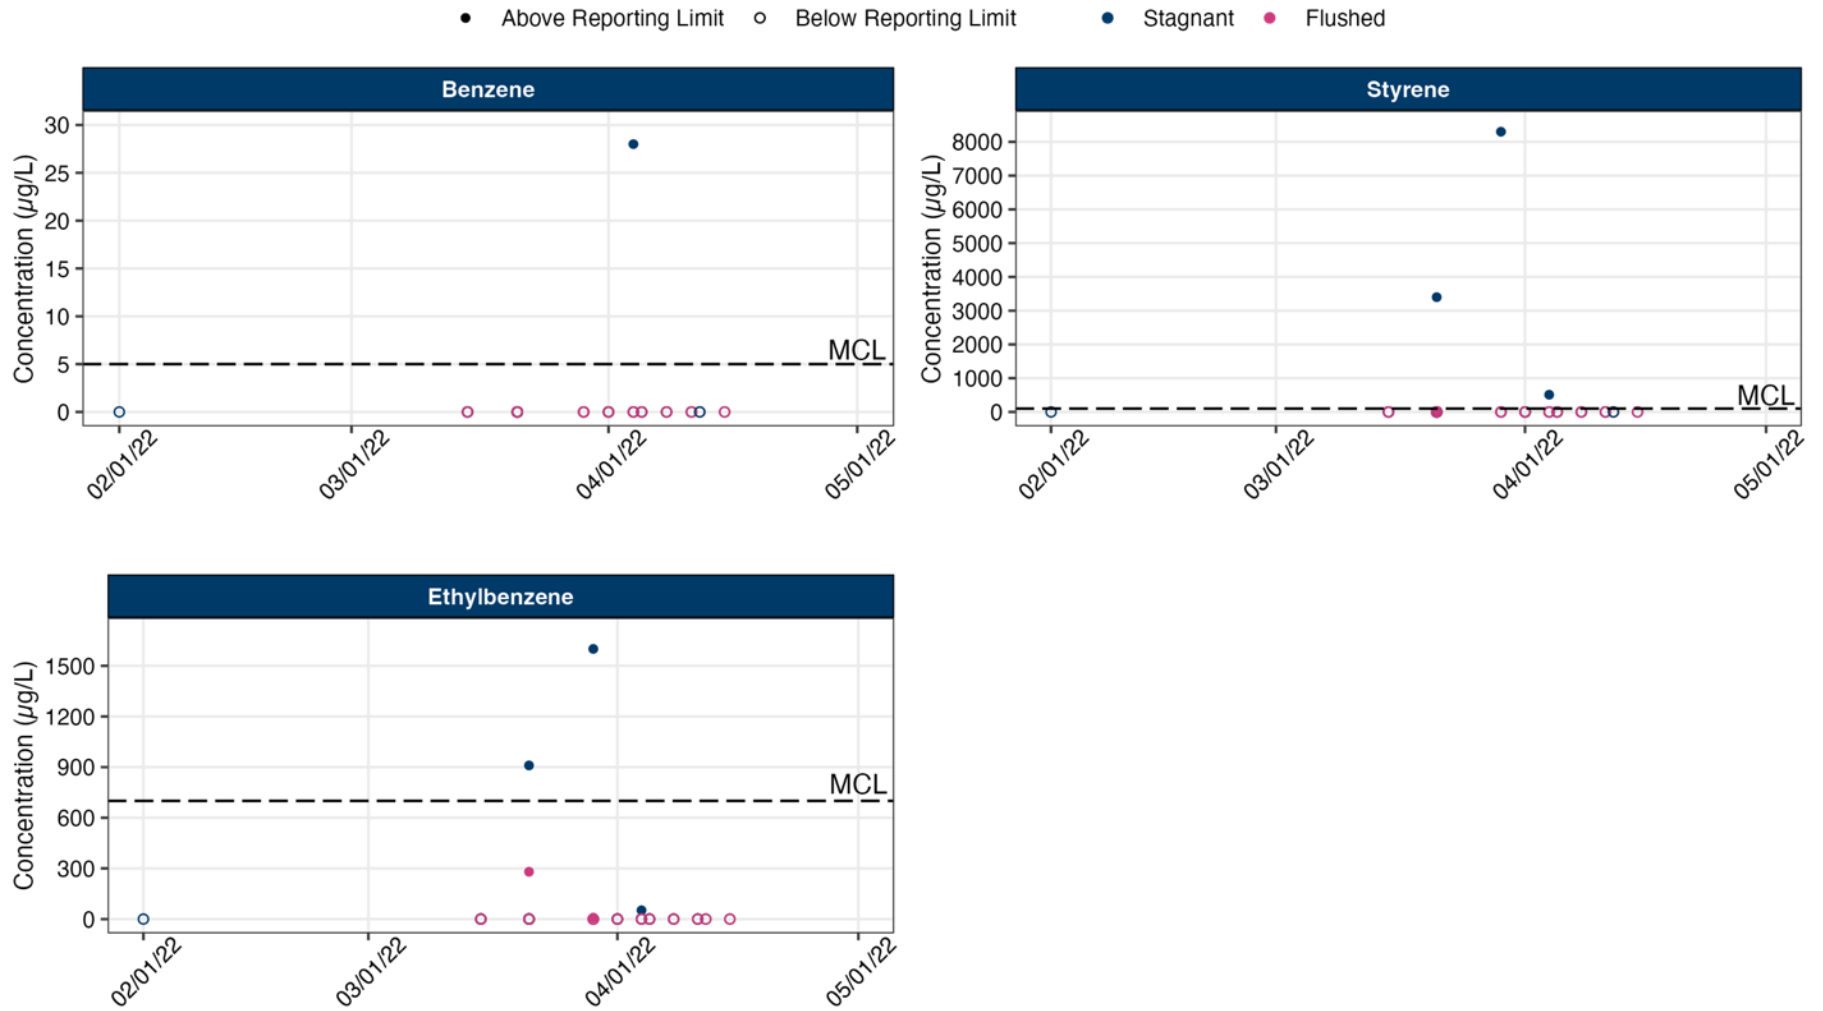
Sample Stage	Contaminant	Number of Detections >MCL	MCL (µg/L)	Maximum Concentration (µg/L)	Detected in Historic Post-Wildfire Drinking Water Sampling
Destroyed Structures	Styrene	3	100	8,300	Y
	Ethylbenzene	2	700	1,600	Y
	Benzene	1	5	28	Y

Figure 14. Contaminants detected above an MCL in destroyed structure sampling

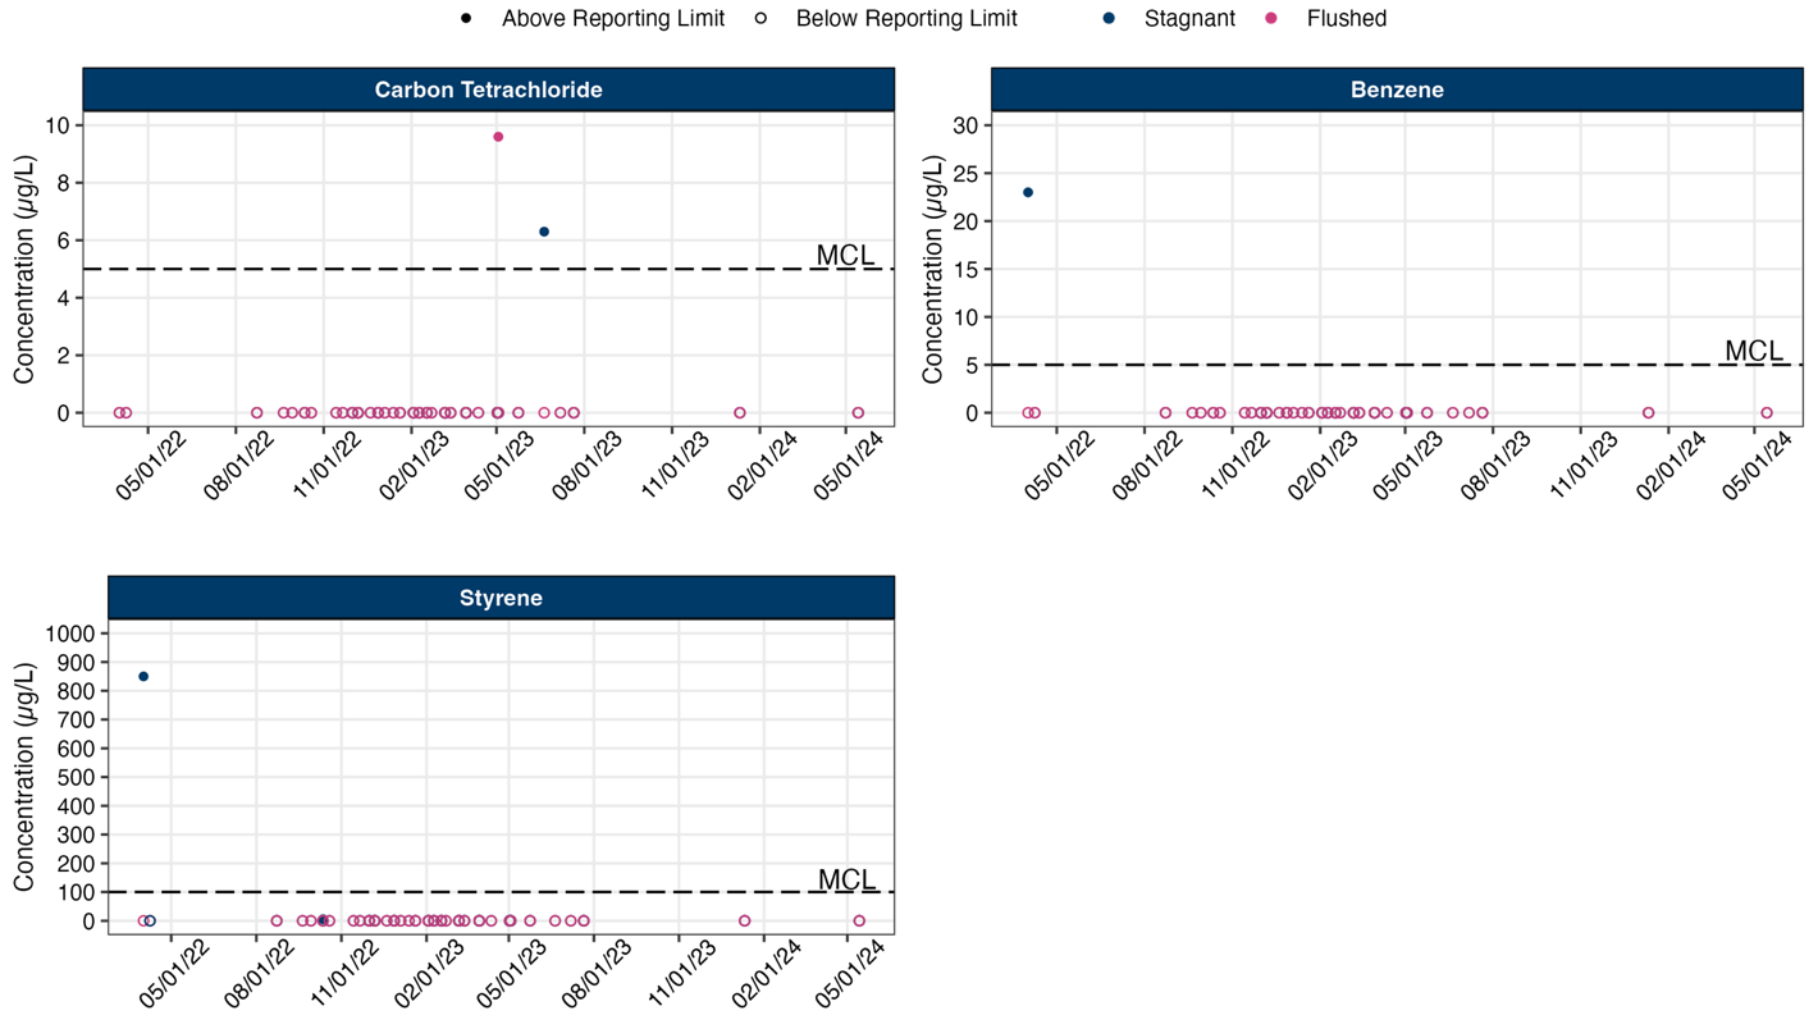
¹Follow up sampling and typical carbon tetrachloride sources indicate possible construction or sampling cross contamination, not fire-related contamination

Figure 15. Contaminants detected above an MCL in meter pit sampling (carbon tetrachloride may be construction or laboratory cross contaminant)
