# Distribution System Monitoring for VOCs and SVOCs After the Marshall Fire

February 13, 2023

# Louisville Water System Overview

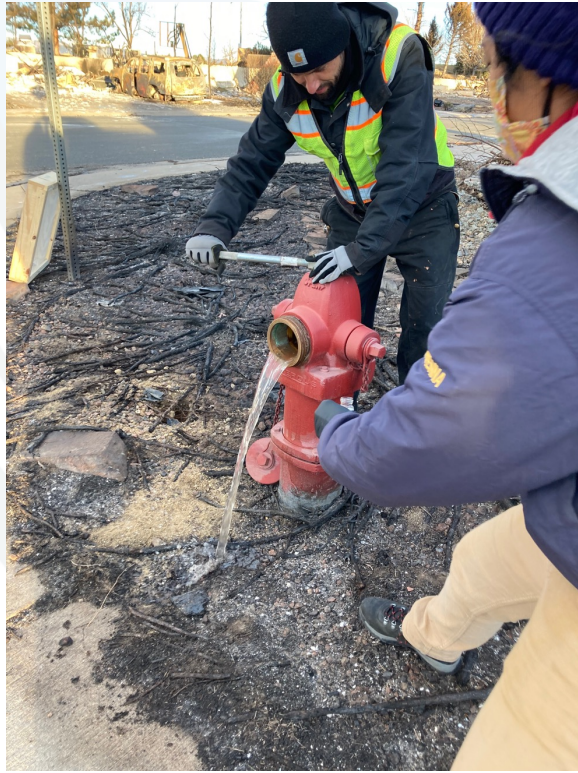
## 1. Distribution system

- Sampling from hydrants and blow-offs prior to opening curb stops

# 1. Distribution system sample methods

- Representative locations selected throughout burn area
- 1<sup>st</sup> sample – stagnant
- 2<sup>nd</sup> sample – flush for ~5 minutes and check chlorine
- Flush and resample as necessary dependent on results
- Hydraulically isolated from undamaged areas until acceptable VOC results
- Precautionary sampling is ongoing

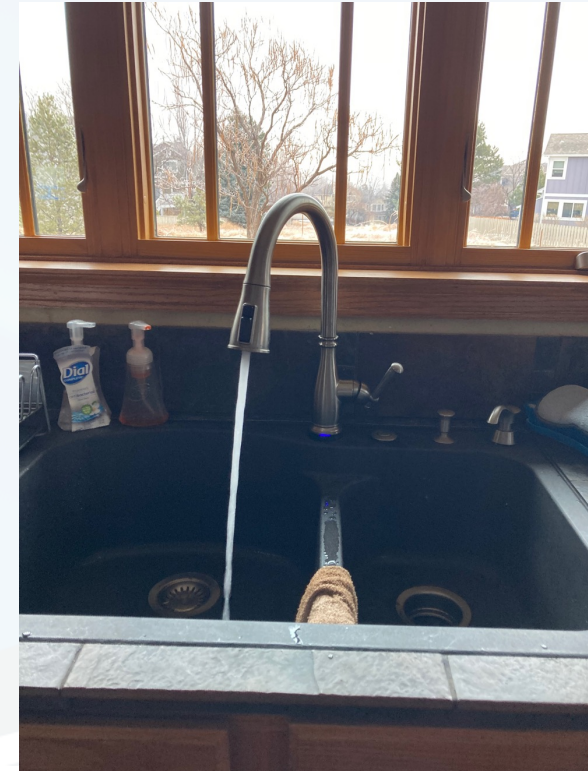
## 2. Standing structures

- Sample habitable structures in burn areas upon clearing the mains

## 2. Standing Structure sample methods

- Upon receiving cleared samples from the main, move to sampling standing structures in the burn area
- Curb stops opened by City staff
- Samples taken from kitchen sink
- 1<sup>st</sup> sample – stagnant
- 2<sup>nd</sup> sample – flush entire home for ~30 minutes, check chlorine
- Curb stop closed again until VOCs are cleared

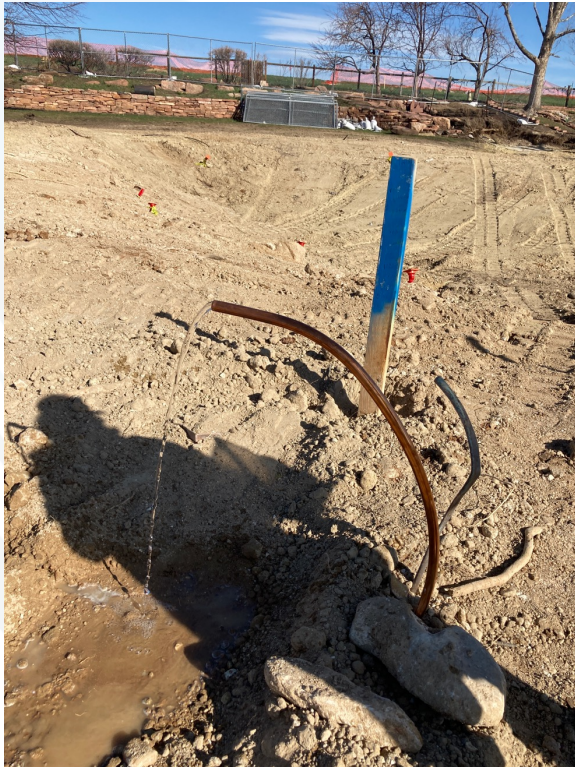
## 3. Burned structures

- Investigate contamination in service lines to burned structures

### 3. Burned Structure sample methods

- After clearing habitable structures, move to investigating subset of burned structure service lines
- Sample from service line to determine required excavation during rebuild process
- 1<sup>st</sup> sample – stagnant
- 2<sup>nd</sup> sample – flush for 5 minutes, check chlorine
- Excavated and resampled as needed

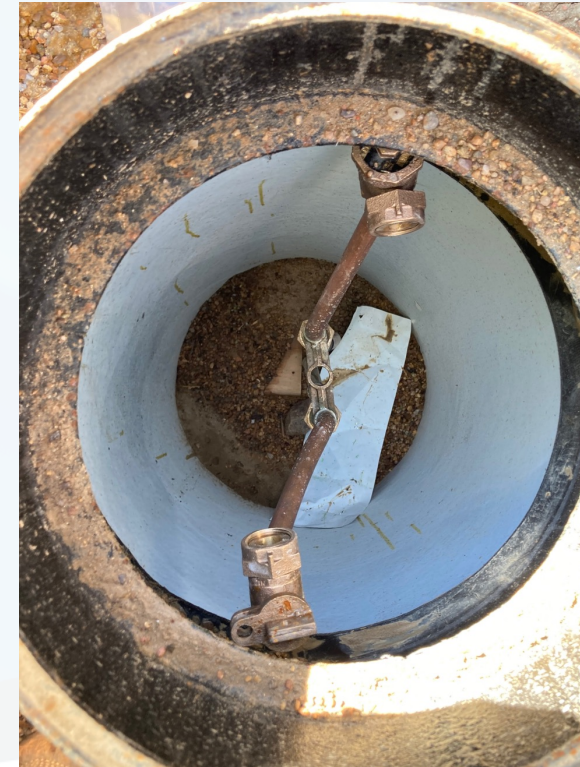
## 4. Meter pits

- Sampling at structures under construction before connecting meter

## 4. Meter pit sample methods

- Meter pit sampling included in permitting and inspection process
- No VOCs detected so far
- May be discontinued upon sampling statistically significant number of locations
- 1<sup>st</sup> sample – stagnant
- 2<sup>nd</sup> sample – flush for 5 minutes, check chlorine
- Meter installed after receiving acceptable results

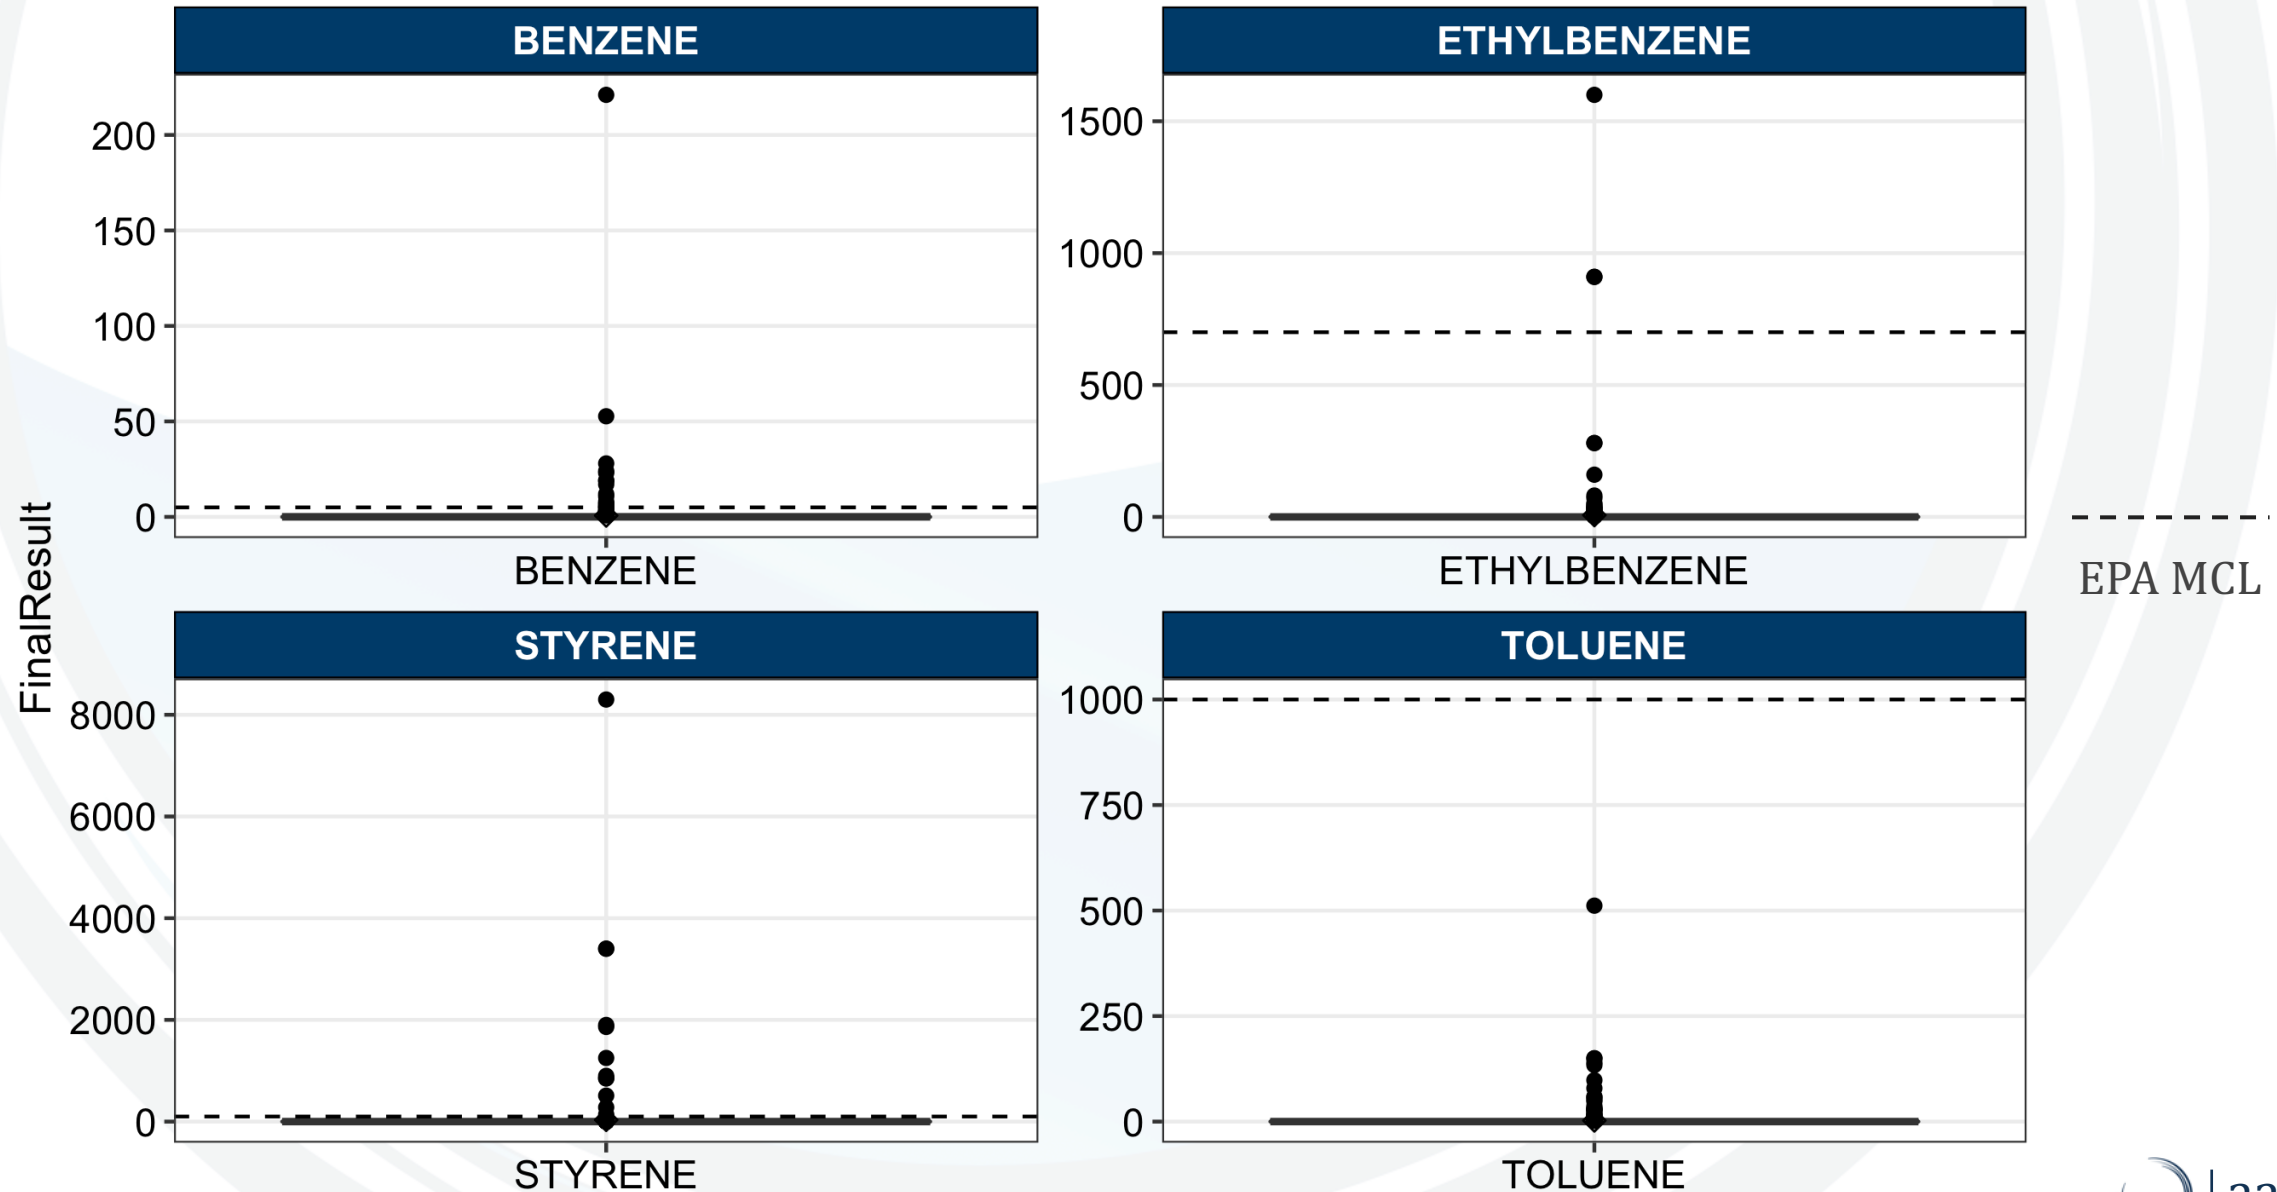
# Most frequently above MDL

- 912 analyses (~1%) were above the MDL
  - Not including THMs
- 30 analyses (<0.1%) exceeded an MCL
  - VOCs: ethylbenzene (3), benzene (15), styrene (12)
  - Follow up samples found that flushing rapidly reduced chemical contamination
