City of Louisville

Marshall Fire Water System Recovery Summary Report

Corona Environmental Consulting, LLC

2/3/2025

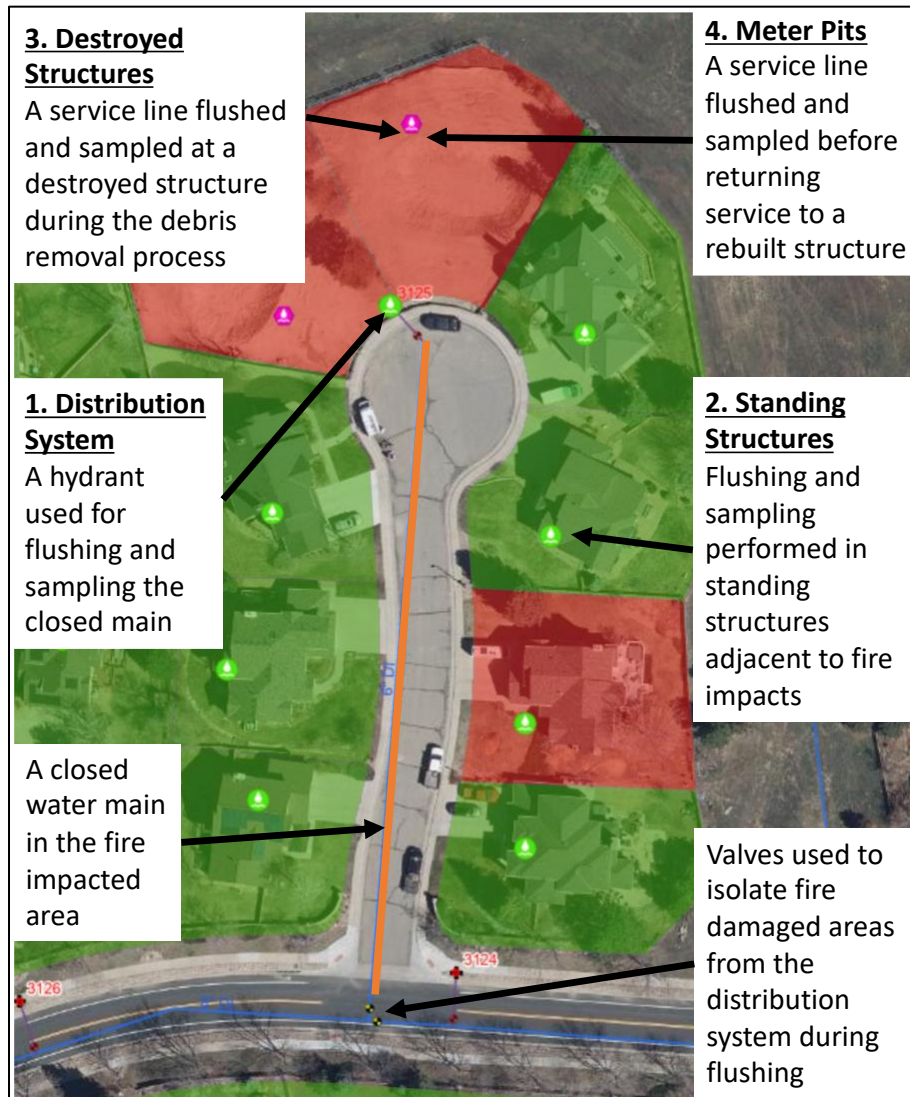
The sampling and analytical plans for each stage of the Water System Recovery are detailed in the following sections. Figure 1 provides an example of the stages of sampling in a fire impacted street in Louisville.

Figure 1. An example of the flushing and sampling stages in a fire impacted neighborhood

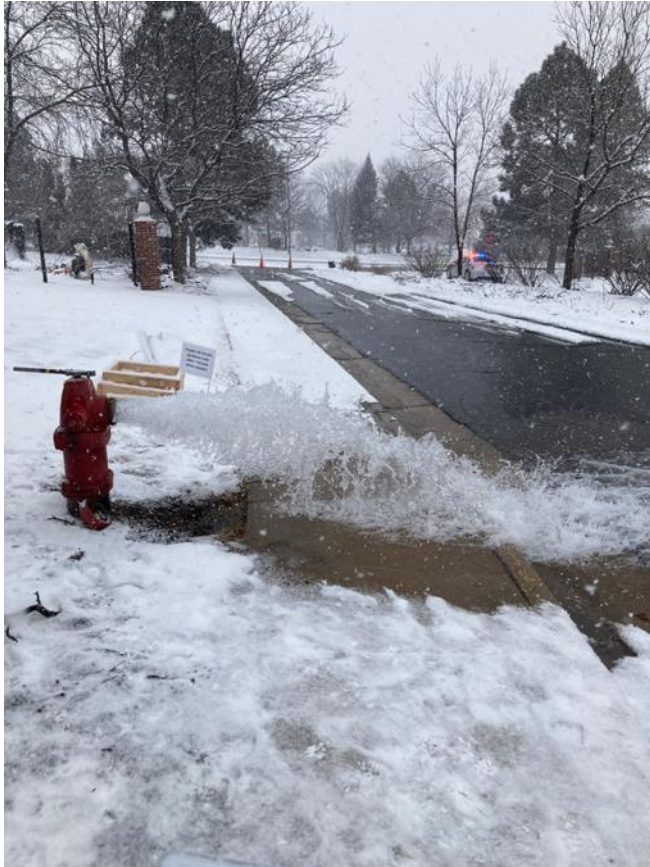
In the immediate aftermath of the fire, Louisville’s primary water system recovery goal became the chlorination and subsequent flushing of the entire distribution system as required to lift the Boil Water Order. While performing flushing (Figure 2), the team utilized field chlorine testing and collected samples to submit to laboratories for microbial contamination monitoring. Additional sampling was performed for contaminants found in recent post-wildfire studies, including VOCs and SVOCs. On January 6, 2022,

Figure 2. A hydrant being used to flush water in the fire impacted area

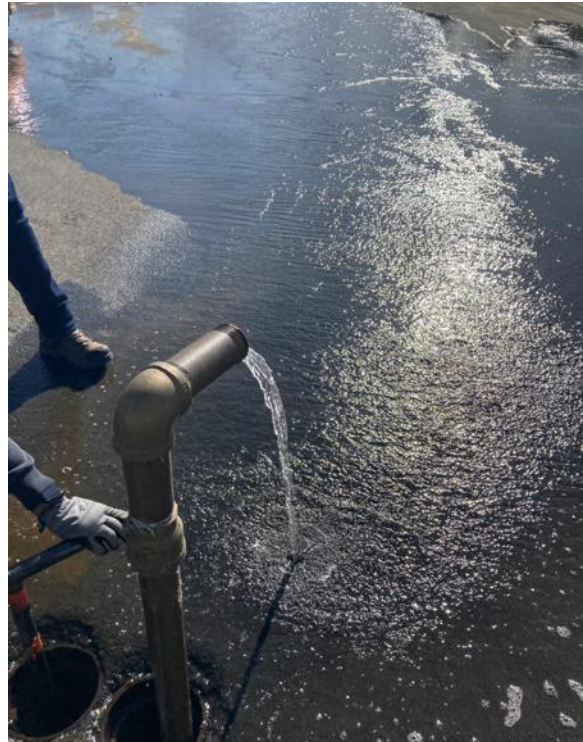
- Louisville staff opened necessary valves to supply water to the hydrant or blow-off.
- The hydrant or blow-off was slowly opened to release a trickle of water (Figure 3).

Figure 3. A blow-off opened to a trickle for sample collection

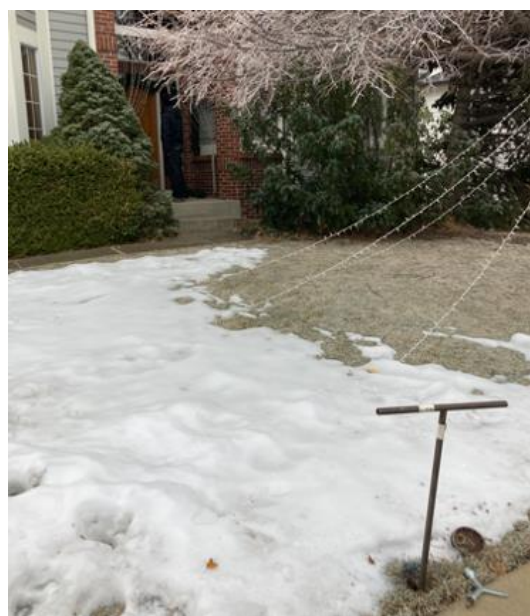
Figure 4. A curb stop used to return water service to a standing structure for flushing and sampling

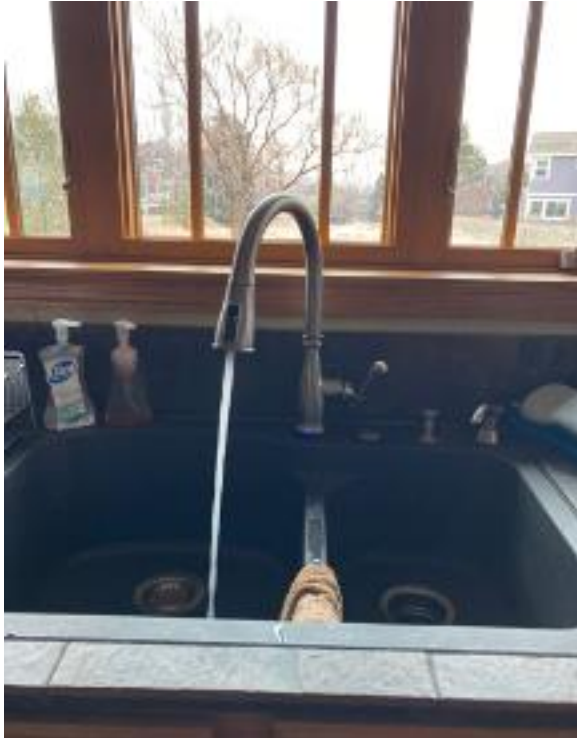
Figure 5. A sink being flushed during sample collection

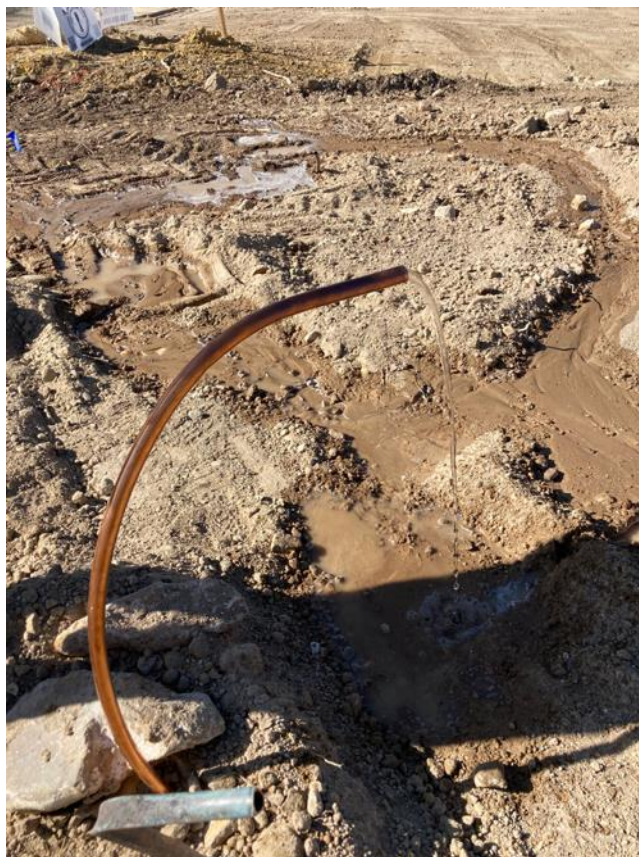
- Louisville staff coordinated with customers to schedule flushing and sampling.
- Several locations were selected where the service line could be accessed safely outside the destroyed building prior to any debris removal. The remaining locations were sampled after debris removal and the contractor left the service line accessible for Louisville sampling Figure 6.

Figure 6. Sampling an accessible service line at a destroyed structure

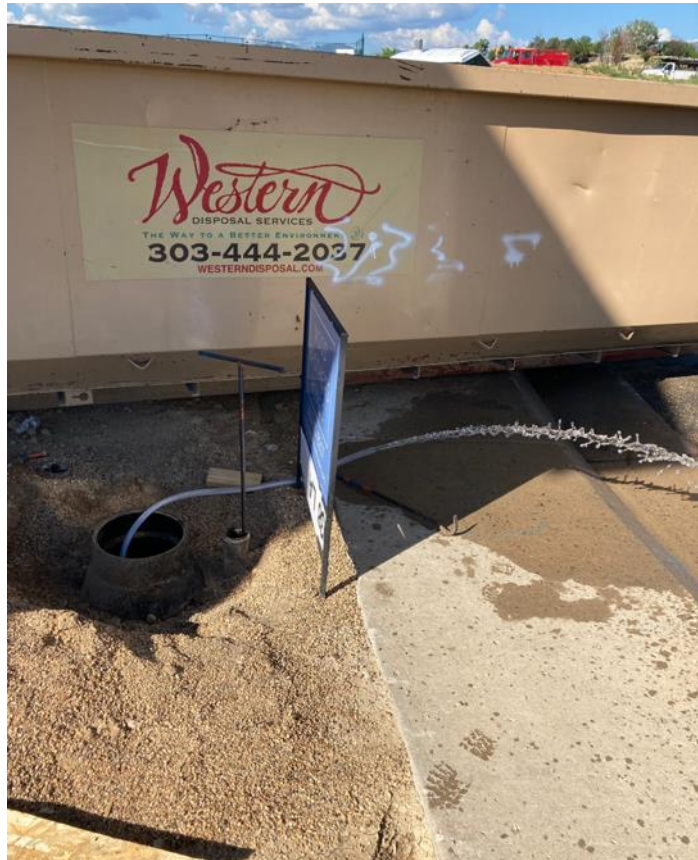
- Corona staff would immediately collect the “stagnant” VOC samples, followed by the “stagnant” SVOC samples.
- The curb stop was then fully opened to flush the service line; a hose was used to run the flushed water to the street if needed (Figure 7)

Figure 7. A meter pit being flushed after stagnant sample collection

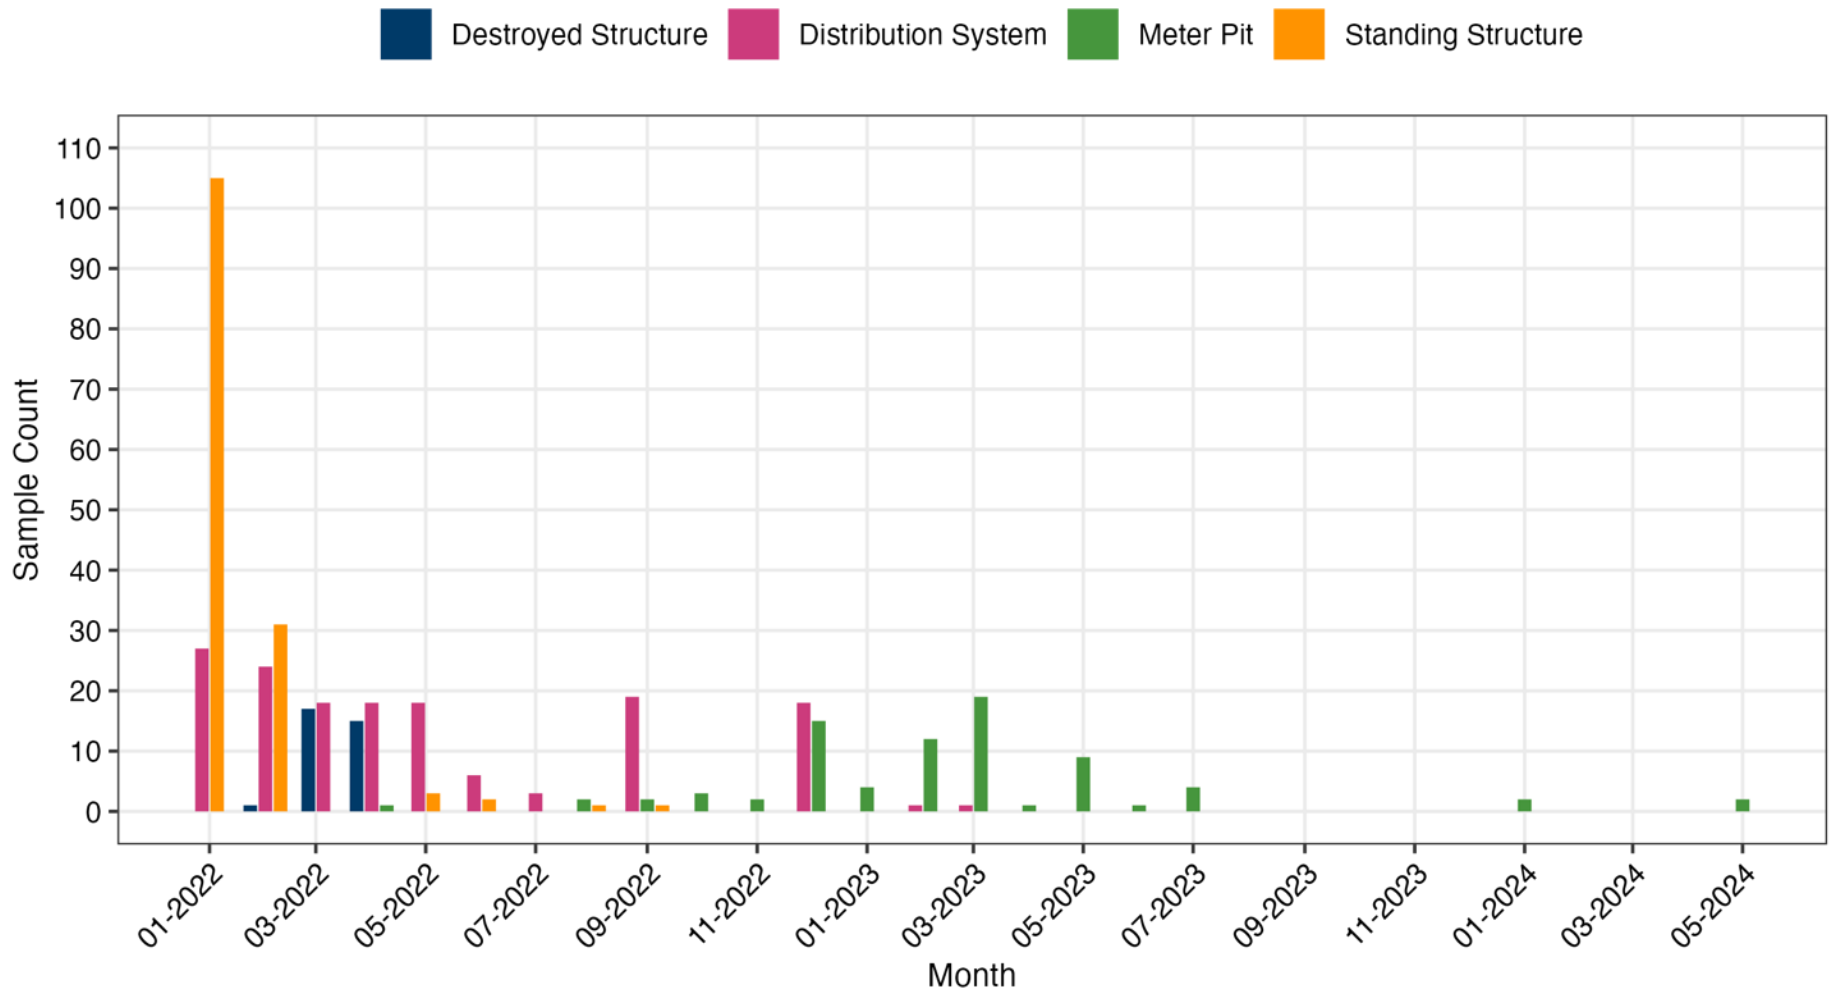
Figure 8 shows the number of sample events occurring per month in each stage of water system recovery. In the initial months after the fire, the focus was on returning water service to un-damaged standing structures by sampling throughout the distribution system as well as inside standing structures. Sampling then moved into destroyed structures and meter pits, while maintaining occasional proactive distribution system sampling to confirm fire related contamination had been fully removed by flushing.

Figure 8. Sample collection events for all stages of water system recovery shown on the dates the sampling occurred

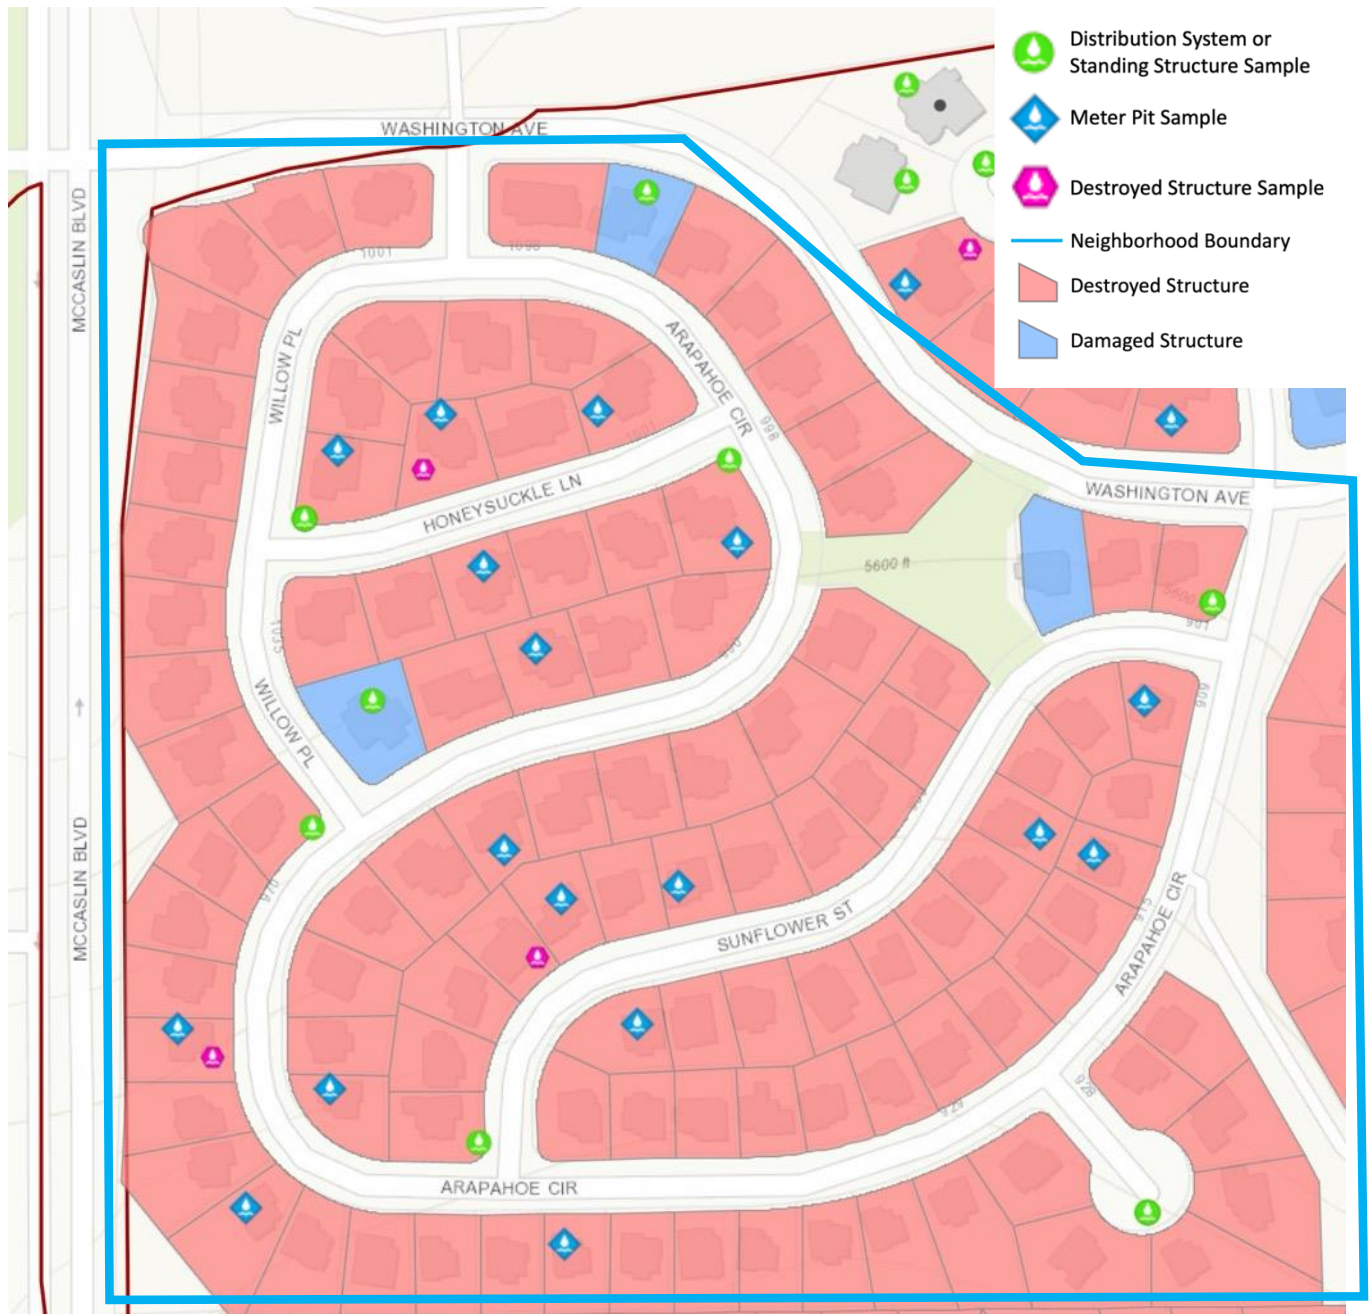
Neighborhood	Sample Stage	Type	Number of Samples	Number of Total Analyses	Number of Total Analyses >MRL	Percent >MRL	Number of Total Analyses >MCL	Percent Exceeding the MCL
Arapahoe	Standing Structure	Stagnant	3	354	1	0.29%	0	0%
		Flushed	2	230	0	0%	0	0%
	Meter Pit	Stagnant	17	1,904	16	0.84%	0	0%
		Flushed	17	1,904	3	0.16%	0	0%
	Distribution System	Stagnant	29	3,549	25	0.70%	4	0.11%
		Flushed	28	3,506	12	0.34%	1	0.03%
	Destroyed Structure	Stagnant	3	345	0	0%	0	0%
		Flushed	3	345	0	0%	0	0%

Figure 16. An overview of the sampling performed in the Arapahoe neighborhood

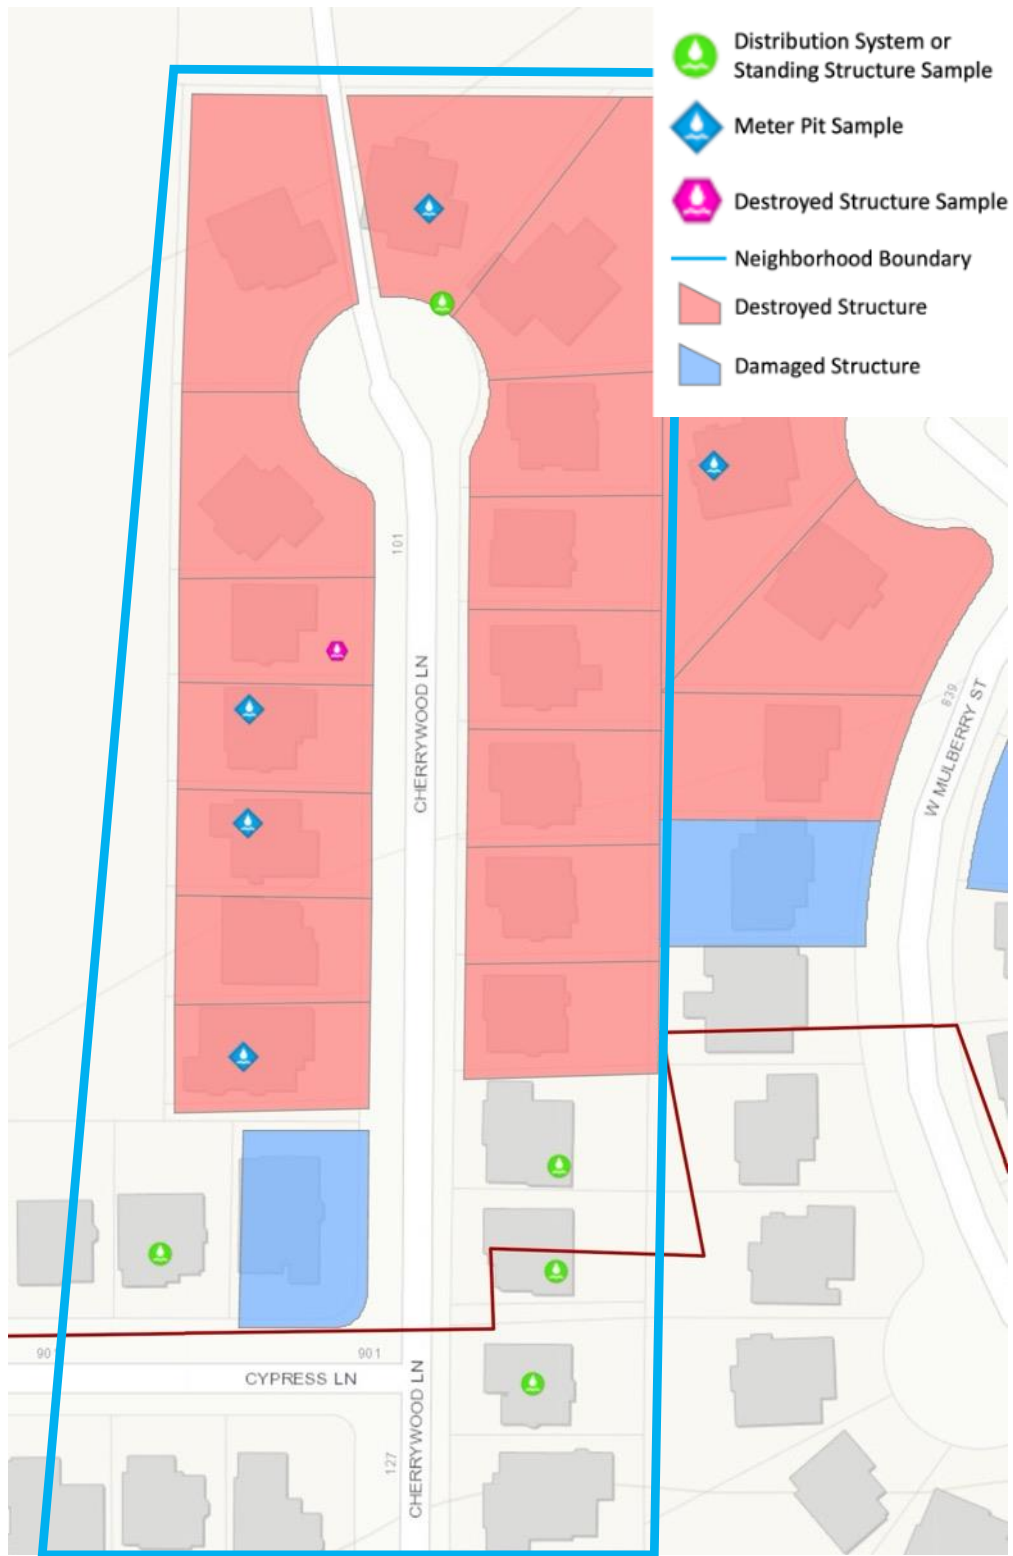
Neighborhood	Sample Stage	Type	Number of Samples	Number of Total Analyses	Number of Total Analyses >MRL	Percent >MRL	Number of Total Analyses >MCL	Percent Exceeding the MCL
Cherrywood	Standing Structure	Stagnant	4	272	1	0.37%	0	0%
		Flushed	2	230	1	0.43%	0	0%
	Meter Pit	Stagnant	4	448	2	0.45%	0	0%
		Flushed	4	448	1	0.22%	0	0%
	Distribution System	Stagnant	5	569	2	0.35%	0	0%
		Flushed	4	457	1	0.22%	0	0%
	Destroyed Structure	Stagnant	1	115	0	0%	0	0%
		Flushed	1	115	0	0%	0	0%

Figure 19. An overview of the sampling performed in the Cherrywood neighborhood

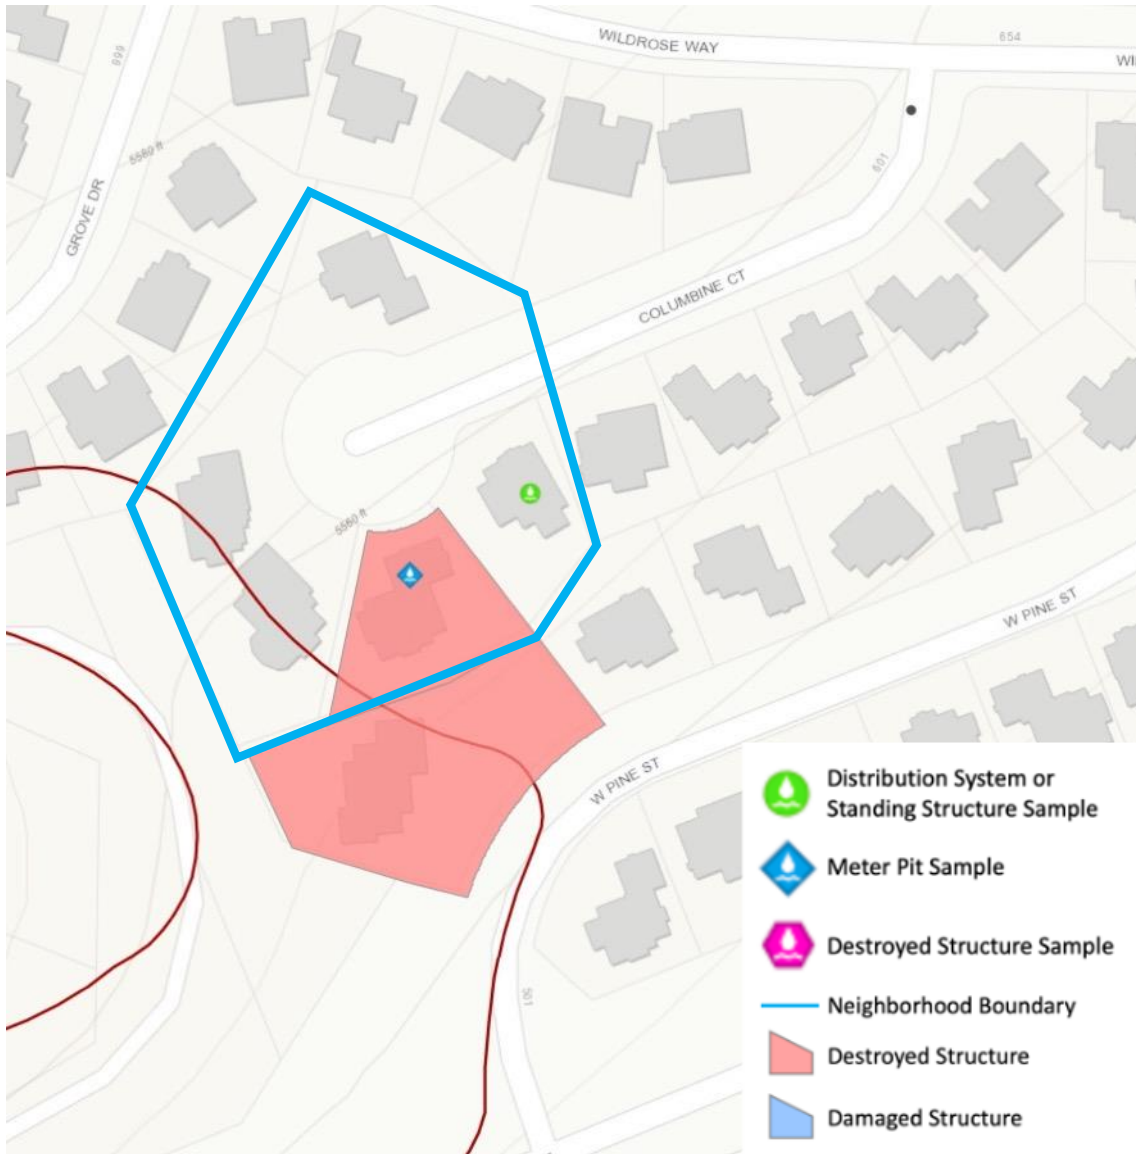
Neighborhood	Sample Stage	Type	Number of Samples	Number of Total Analyses	Number of Total Analyses >MRL	Percent >MRL	Number of Total Analyses >MCL	Percent Exceeding the MCL
Columbine	Standing Structure	Stagnant	1	21	0	0%	0	0%
	Meter Pit	Stagnant	1	112	10	8.93%	0	0%
		Flushed	1	112	1	0.89%	0	0%

Figure 21. An overview of the sampling performed in the Columbine neighborhood

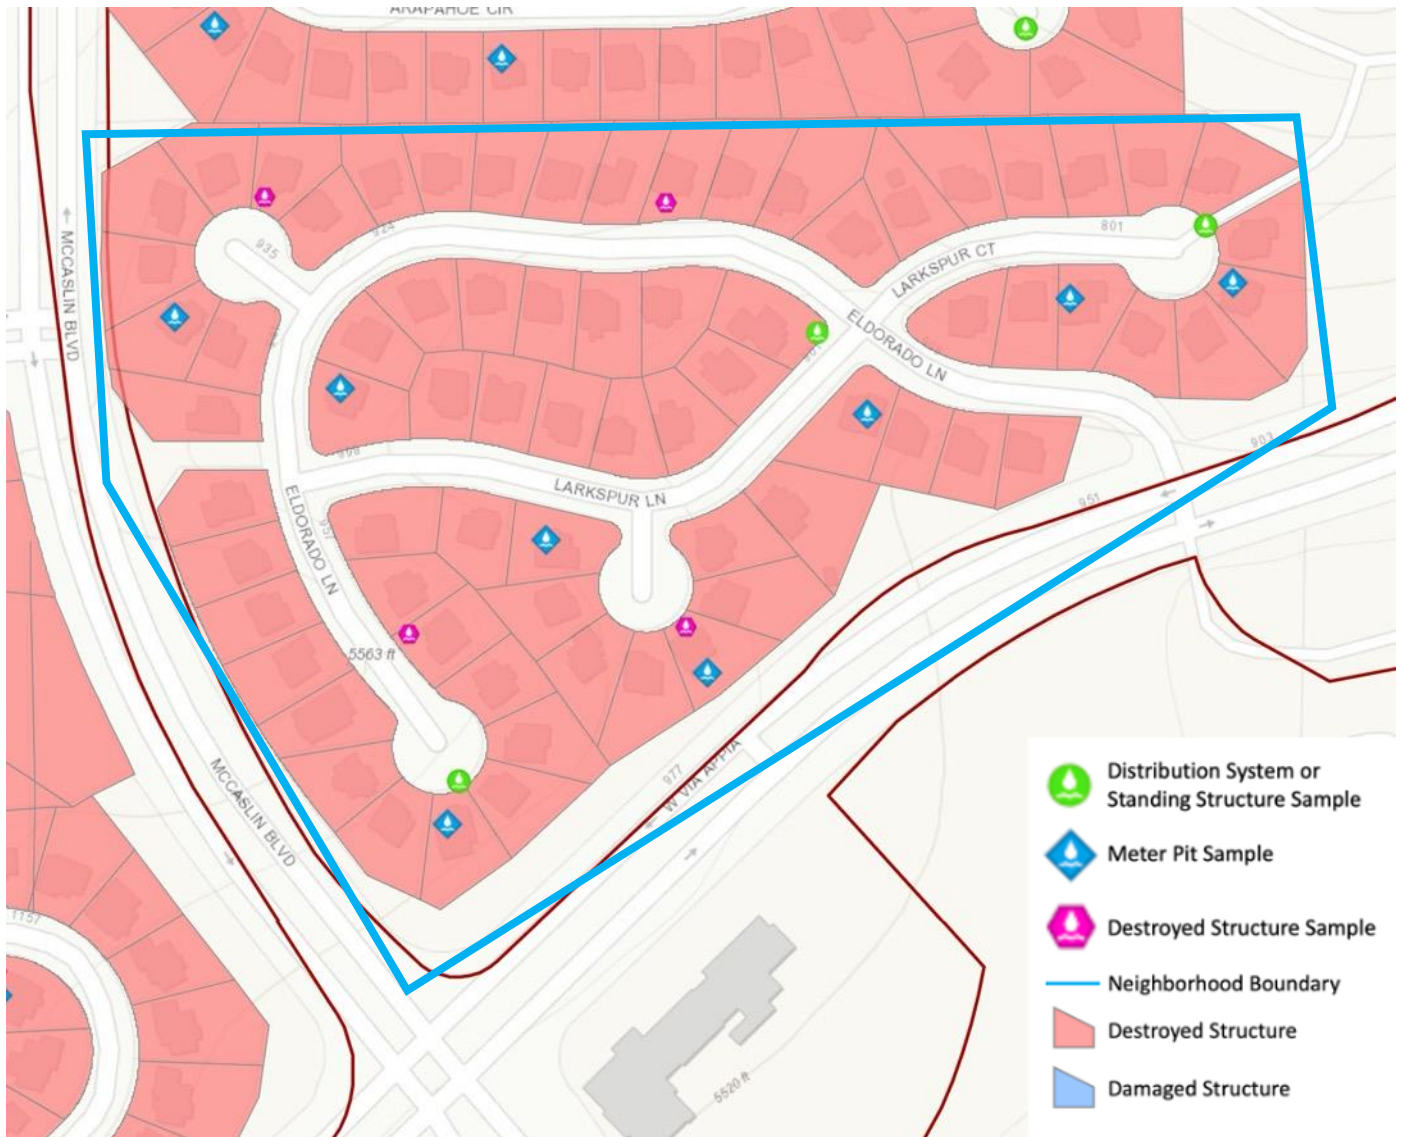
Neighborhood	Sample Stage	Type	Number of Samples	Number of Total Analyses	Number of Total Analyses >MRL	Percent >MRL	Number of Total Analyses >MCL	Percent Exceeding the MCL
Eldorado	Meter Pit	Stagnant	8	896	3	0.33%	0	0%
		Flushed	8	896	2	0.22%	0	0%
	Distribution System	Stagnant	25	2,563	8	0.31%	0	0%
		Flushed	25	2,425	8	0.33%	0	0%
	Destroyed Structure	Stagnant	4	460	0	0%	0	0%
		Flushed	4	460	0	0%	0	0%

Figure 24. An overview of the sampling performed in the Eldorado neighborhood

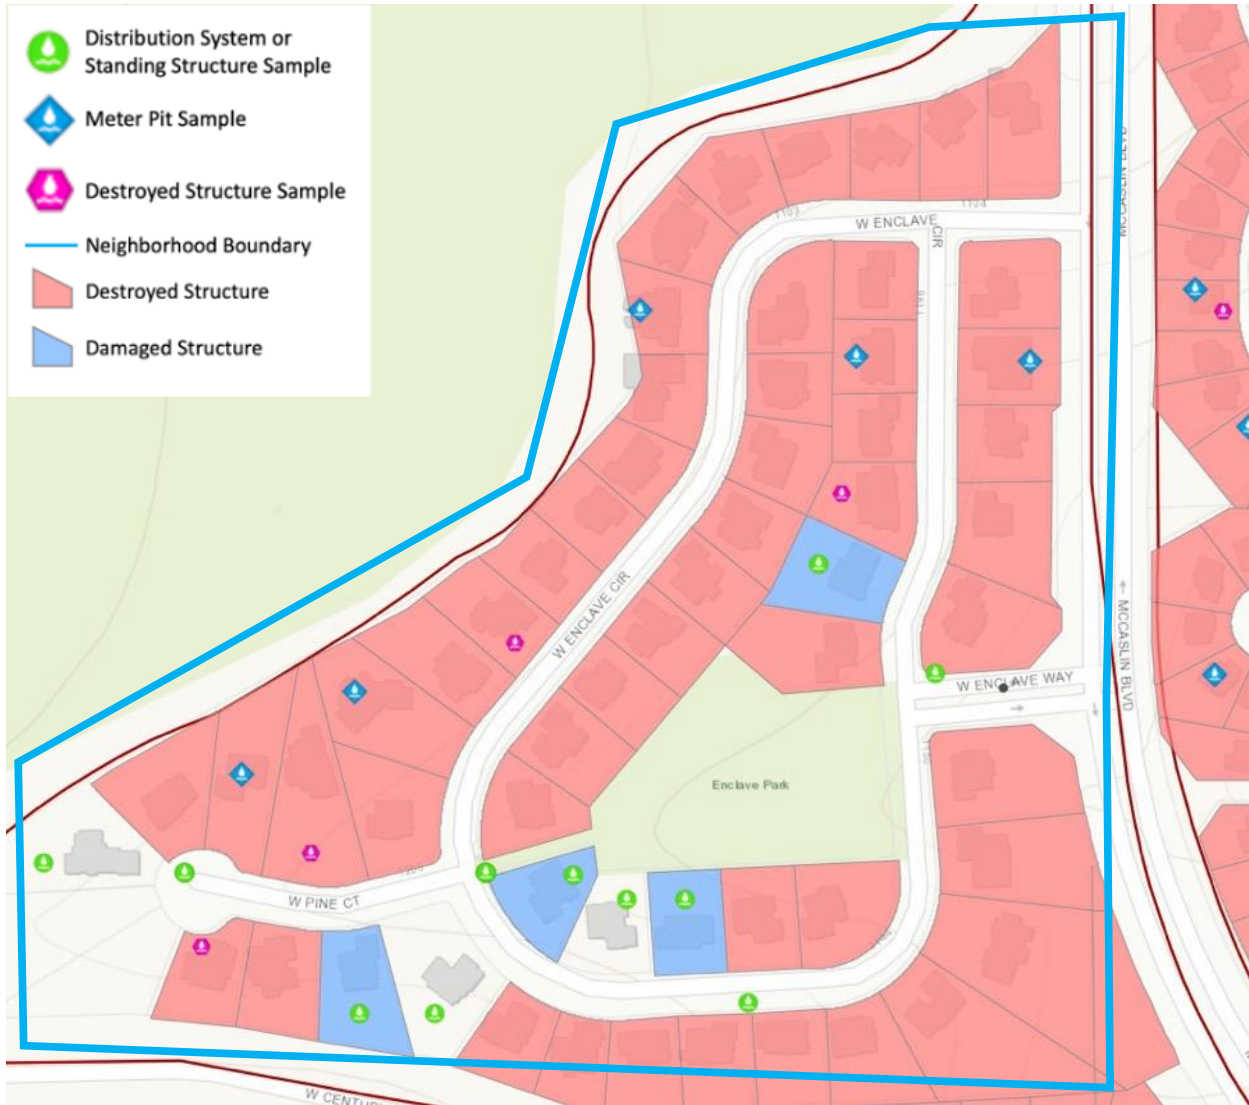
Neighborhood	Sample Stage	Type	Number of Samples	Number of Total Analyses	Number of Total Analyses >MRL	Percent >MRL	Number of Total Analyses >MCL	Percent Exceeding the MCL
Enclave	Standing Structure	Stagnant	7	736	0	0%	0	0%
		Flushed	6	690	0	0%	0	0%
	Meter Pit	Stagnant	4	448	3	0.67%	0	0%
		Flushed	4	448	3	0.67%	0	0%
	Distribution System	Stagnant	11	1,101	5	0.45%	0	0%
		Flushed	11	1,397	2	0.14%	0	0%
	Destroyed Structure	Stagnant	2	230	0	0%	0	0%
		Flushed	2	230	0	0%	0	0%

Figure 25. An overview of the sampling performed in the Enclave neighborhood

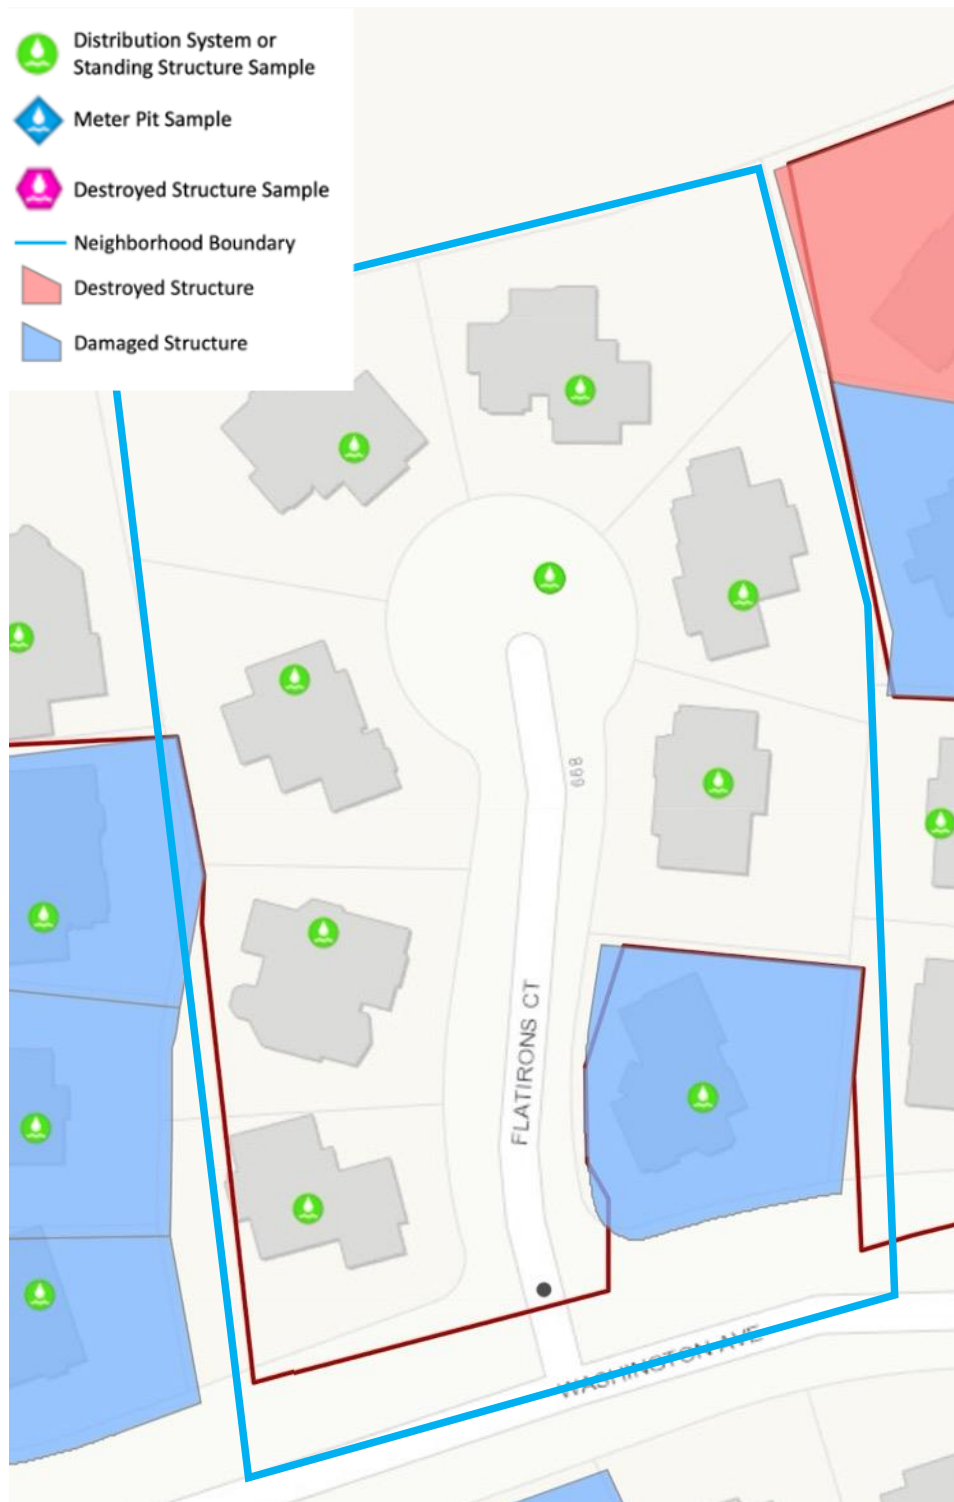
Neighborhood	Sample Stage	Type	Number of Samples	Number of Total Analyses	Number of Total Analyses >MRL	Percent >MRL	Number of Total Analyses >MCL	Percent Exceeding the MCL
Flatirons	Standing Structure	Stagnant	8	644	0	0%	0	0%
		Flushed	8	644	1	0.16%	0	0%
	Distribution System	Stagnant	6	615	1	0.16%	0	0%
		Flushed	6	615	1	0.16%	0	0%

Figure 28. An overview of the sampling performed in the Flatirons neighborhood
